MISCELLANEOUS PAPER GL-91-6

# GEOPHYSICAL SURVEYS FOR LOCATION OF A SUSPECTED ABANDONED MINE OPENING: GRAYS LANDING SITE

March 1991

Final Report

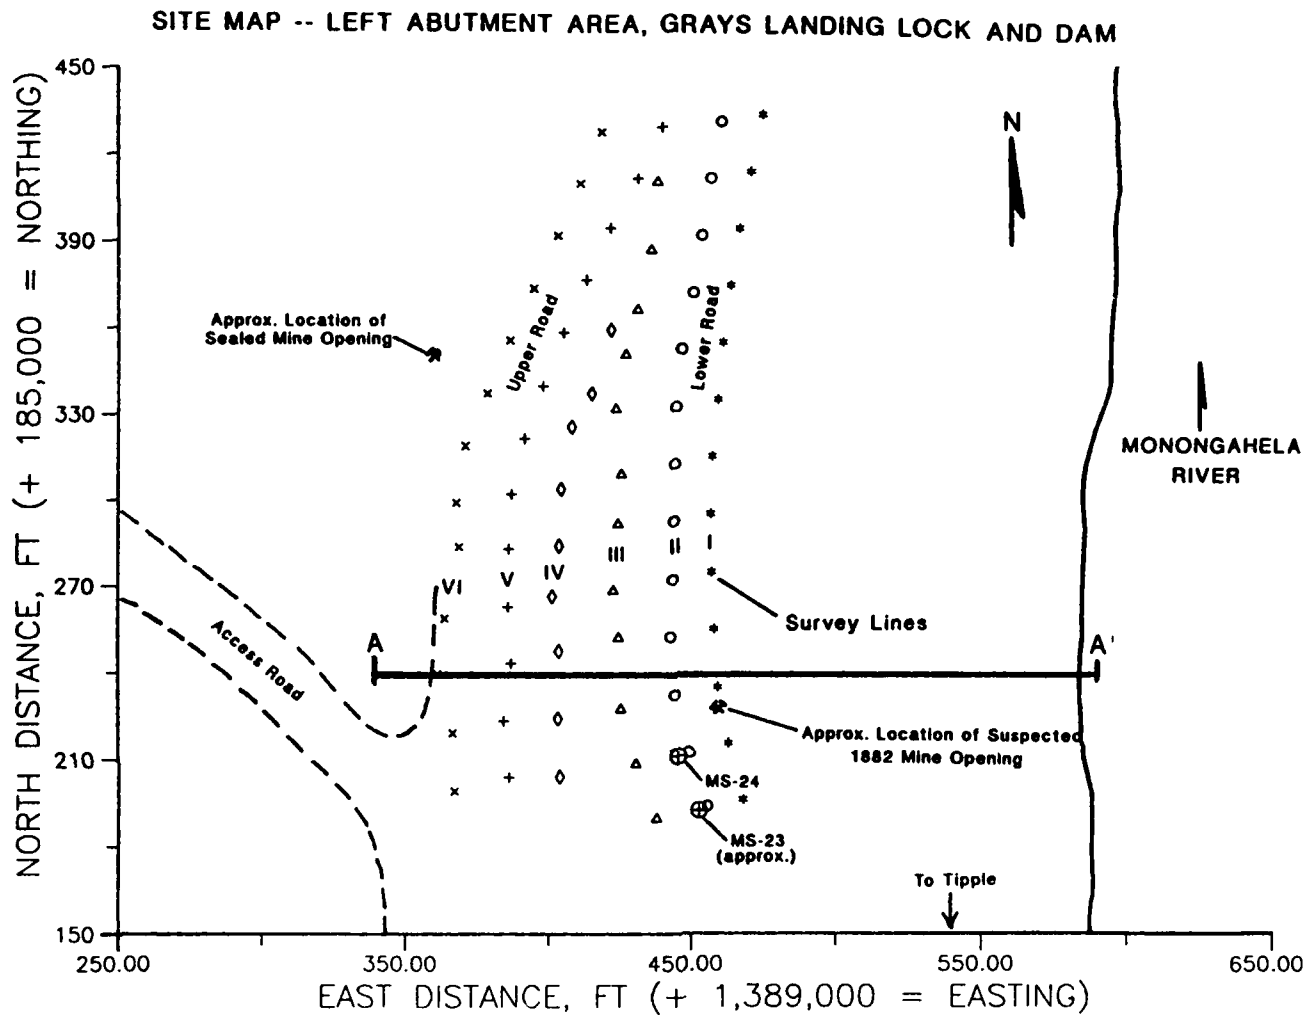
Figure 1a. Geophysical survey site map. Roman Numerals indicate geophysical survey lines. Symbols along survey lines indicate flagged locations.

2. Geophysical survey lines established in the left abutment area specified by District personnel are shown in Figure 1a. Various site features are also indicated in Figure 1a, including approximate locations for the sealed mine opening and the suspected 1882 mine opening. MS-23 and MS-24 are existing exploratory borings. The survey line locations were determined

by a Pittsburgh District survey team, the approximate mine opening locations were obtained from "Evaluation of Left Bank (Abutment Side) Mine Seal and Cut Slope Requirements," Appendix D of Design Memorandum No.4, Feature Design Memorandum, Grays Landing Lock and Dam\*, and other site features were obtained from a Borings Plan/Topographic Map provided by District personnel. Figure 1b is a cross-section from the above reference along cross-section AA' in Figure 1a. The individual survey lines are identified in Figures 1a and 2 by Roman Numerals.

3. The survey lines were located by the geophysical survey team and flagged at 20 ft intervals; flagged locations are indicated in Figures 1 and 2 by different symbols for each line. Geophysical measurements along lines I, II, V, and VI were obtained at 10 ft intervals, where points between flags were located by pacing. Lines I and II and lines V and VI are located along the sides of the Lower Road and the Upper Road, respectively, as indicated in Figure 1a. Measurements along lines III and IV, located on a steep slope, were obtained at 20 ft intervals. The following tabulation summarizes the geophysical surveys conducted at the site and gives approximate or "rule of thumb" depths of investigation:

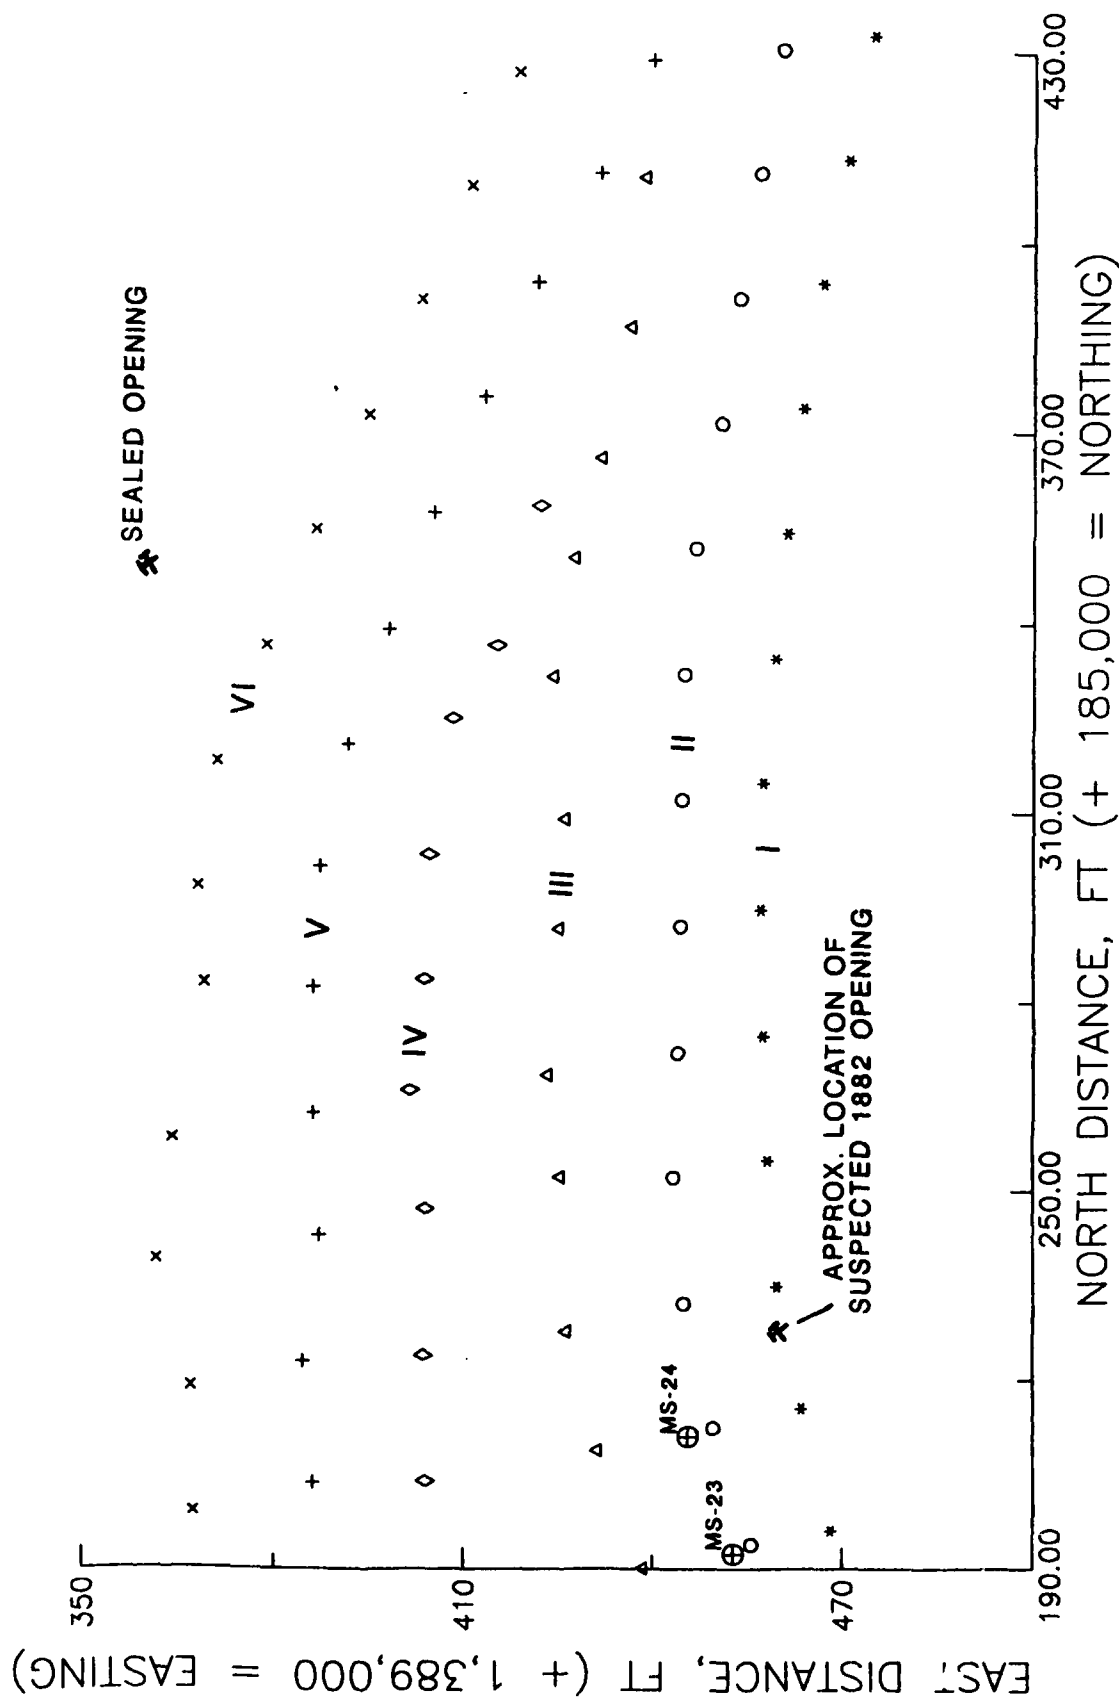
Figure 2. Geophysical survey lines, designated by Roman Numerals. Different symbols for each survey line designate flagged locations at 20 ft spacing

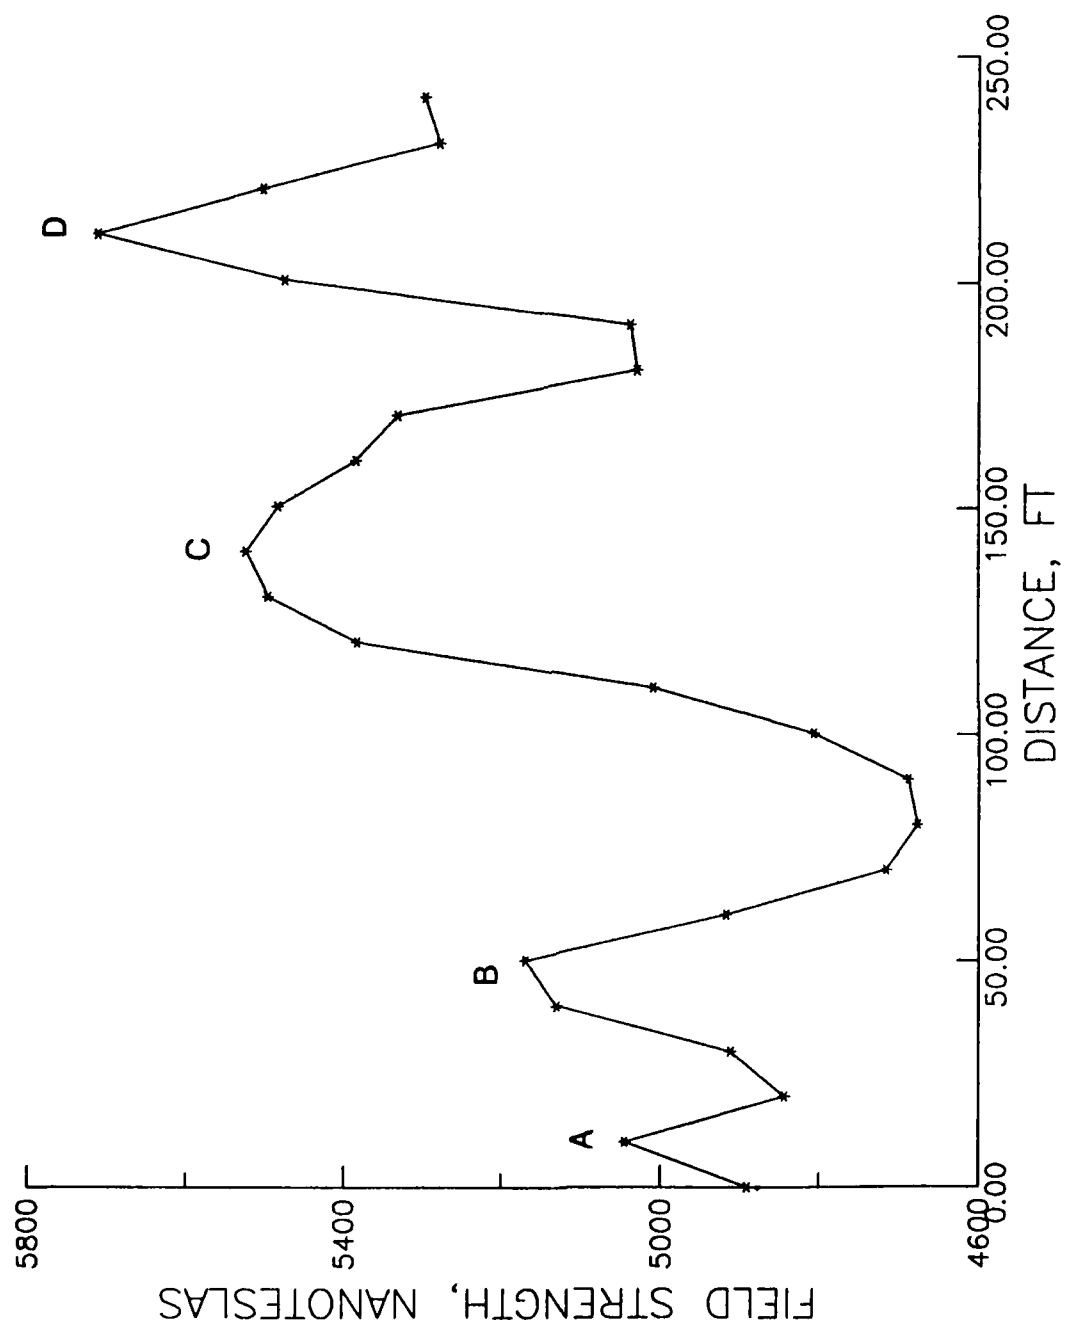
Figure 3. Magnetic survey data, line 1

8. Variation of the magnetic field strength with time, during the survey, was negligible. The field strength values in Figures 3-6 are the measured total magnetic field strengths minus 50,000 nT. Results of the magnetic survey exhibit significant variation along each of the survey lines. Due to their close proximity, lines I and II are qualitatively similar with regard to number and location of maxima and minima. Likewise, lines V and VI are qualitatively similar. There is also some qualitative similarity between the two sets of survey lines; this similarity is indicated in Figures 3-6 by letter labels assigned to the major profile maxima. It appears that the features causing the magnetic anomalies are elongated and pass under the survey lines more or less perpendicular to the lines, consistent with the suspected drift access into the abandoned mine. The qualitative similarity of the anomalies on the four survey lines insures that the anomalies are caused by subsurface metallic features and not scattered surface metallic debris. One qualitative difference between the two sets of magnetic survey data is that overall the magnetic field strength for survey lines I and II increases with increasing distance along the profile line while the data for lines V and VI decrease with increasing distance. This qualitative difference may be due somehow to the fact that the surface elevation increases with distance along I and II but decreases with distance along V and VI.

anomaly maxima to a location under the point of maximum rate of change (slope) (approximately midway) between a maximum and the adjacent minimum located to the north. Closely spaced, sub-surface metallic objects produce magnetic anomalies which overlap, and thus the individual magnetic anomalies cannot be observed completely. Anomaly locations are specified in such a way, i.e., in bands, that this range of possibilities is included; this fact must be remembered when locating boreholes or excavations. Figure 11 is the magnetic anomaly location map, where anomaly bands are indicated and labeled to correspond to anomalies identified in Figures 3-6. Within the bands, locations of the anomaly maxima and points of maximum slope are indicated.

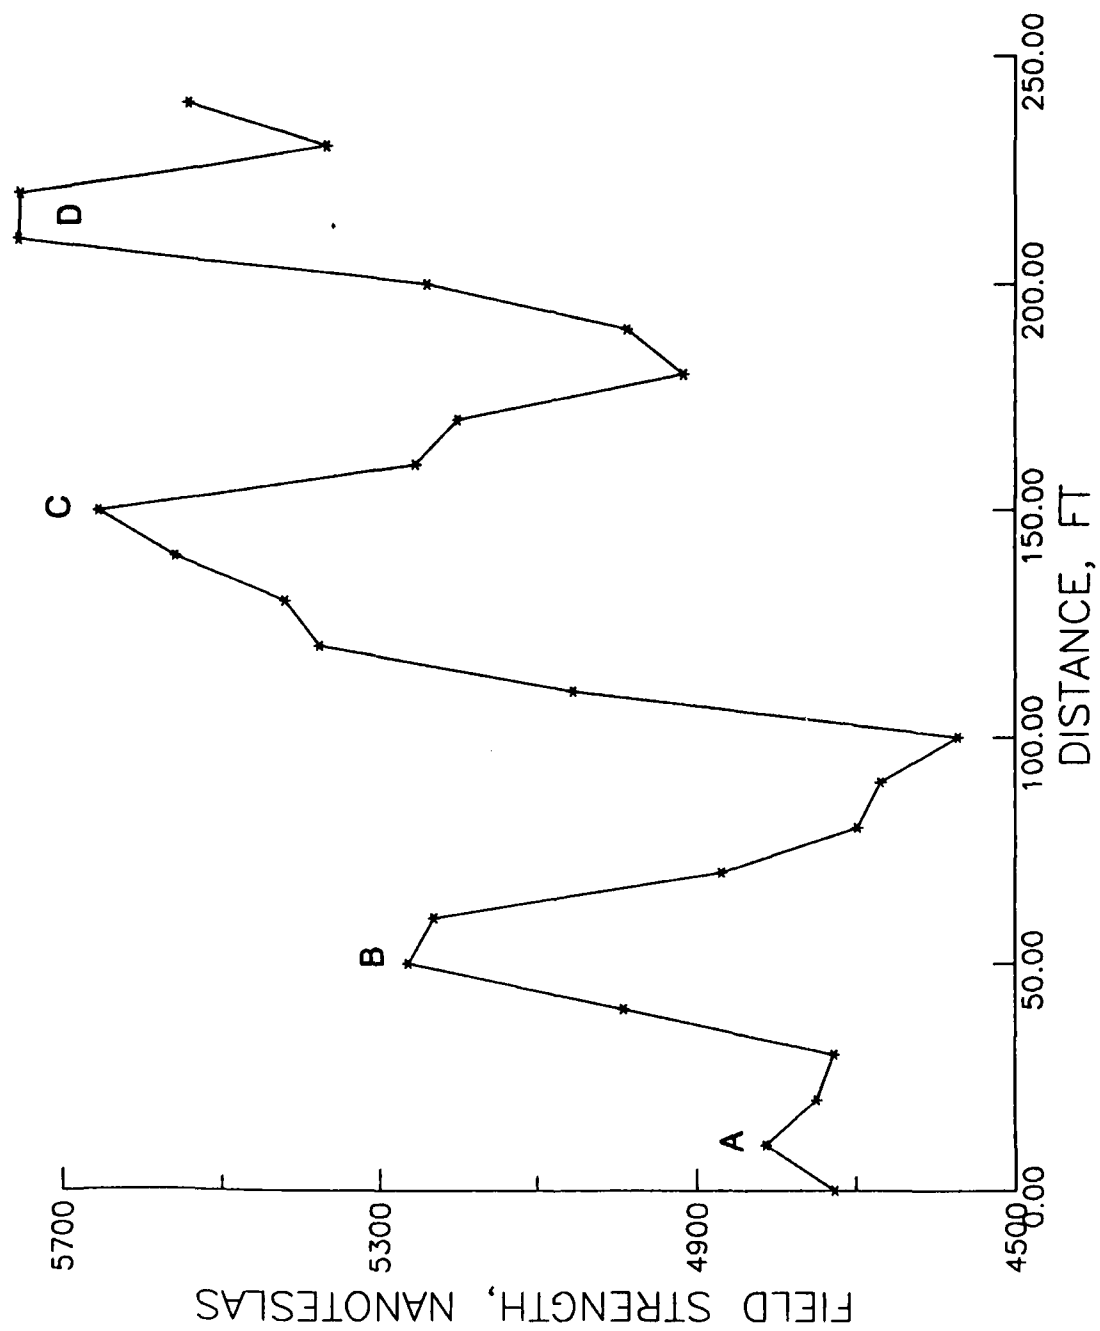
Figure 4. Magnetic survey data, line II

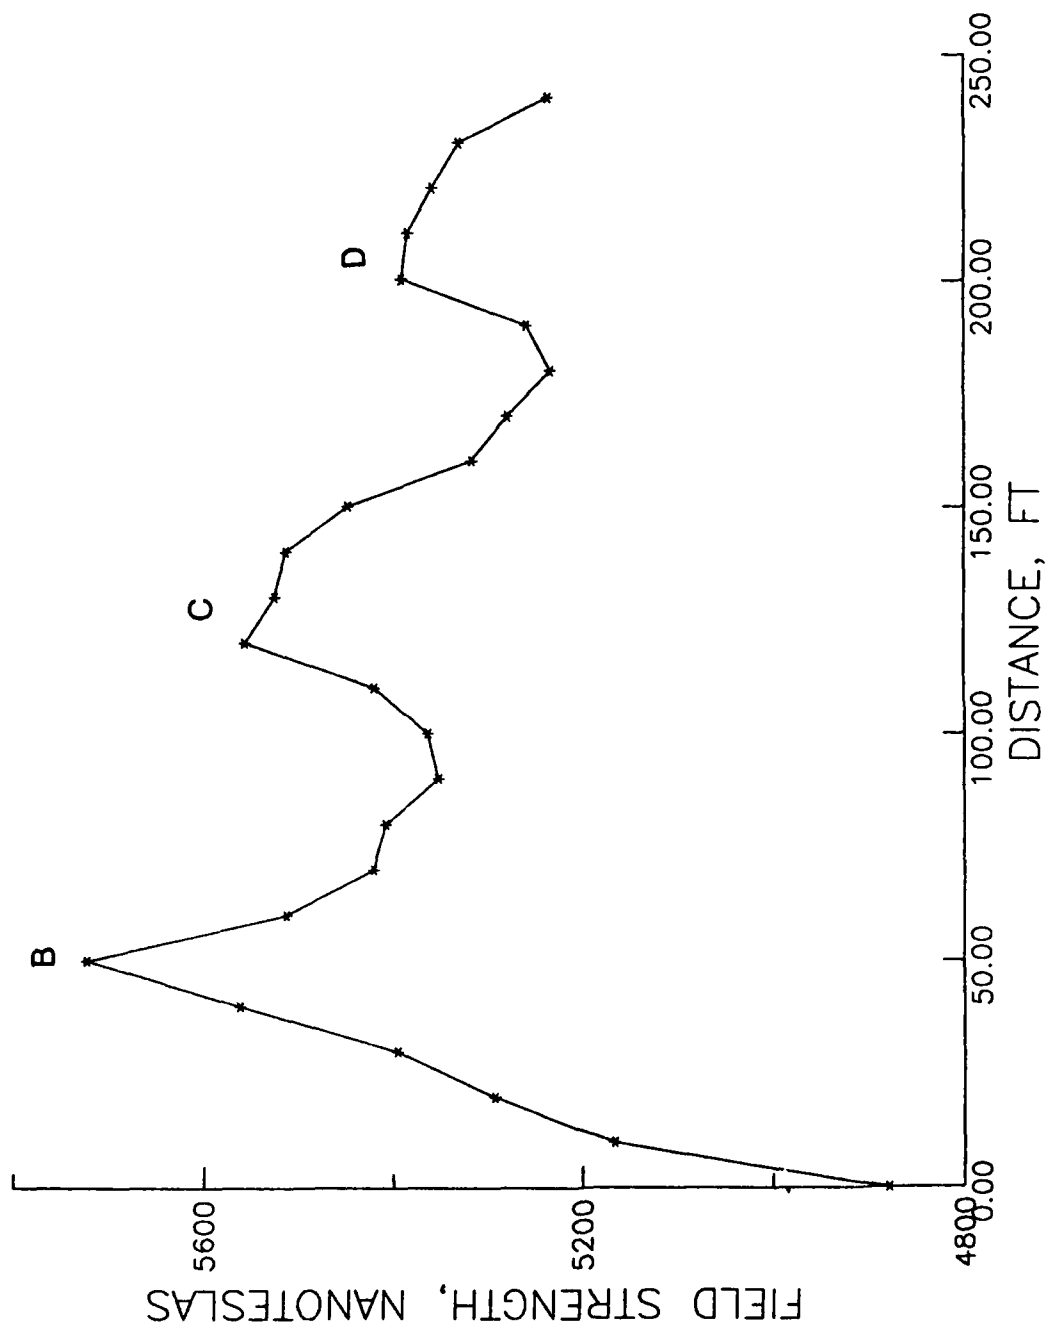
Figure 5. Magnetic survey data, line V

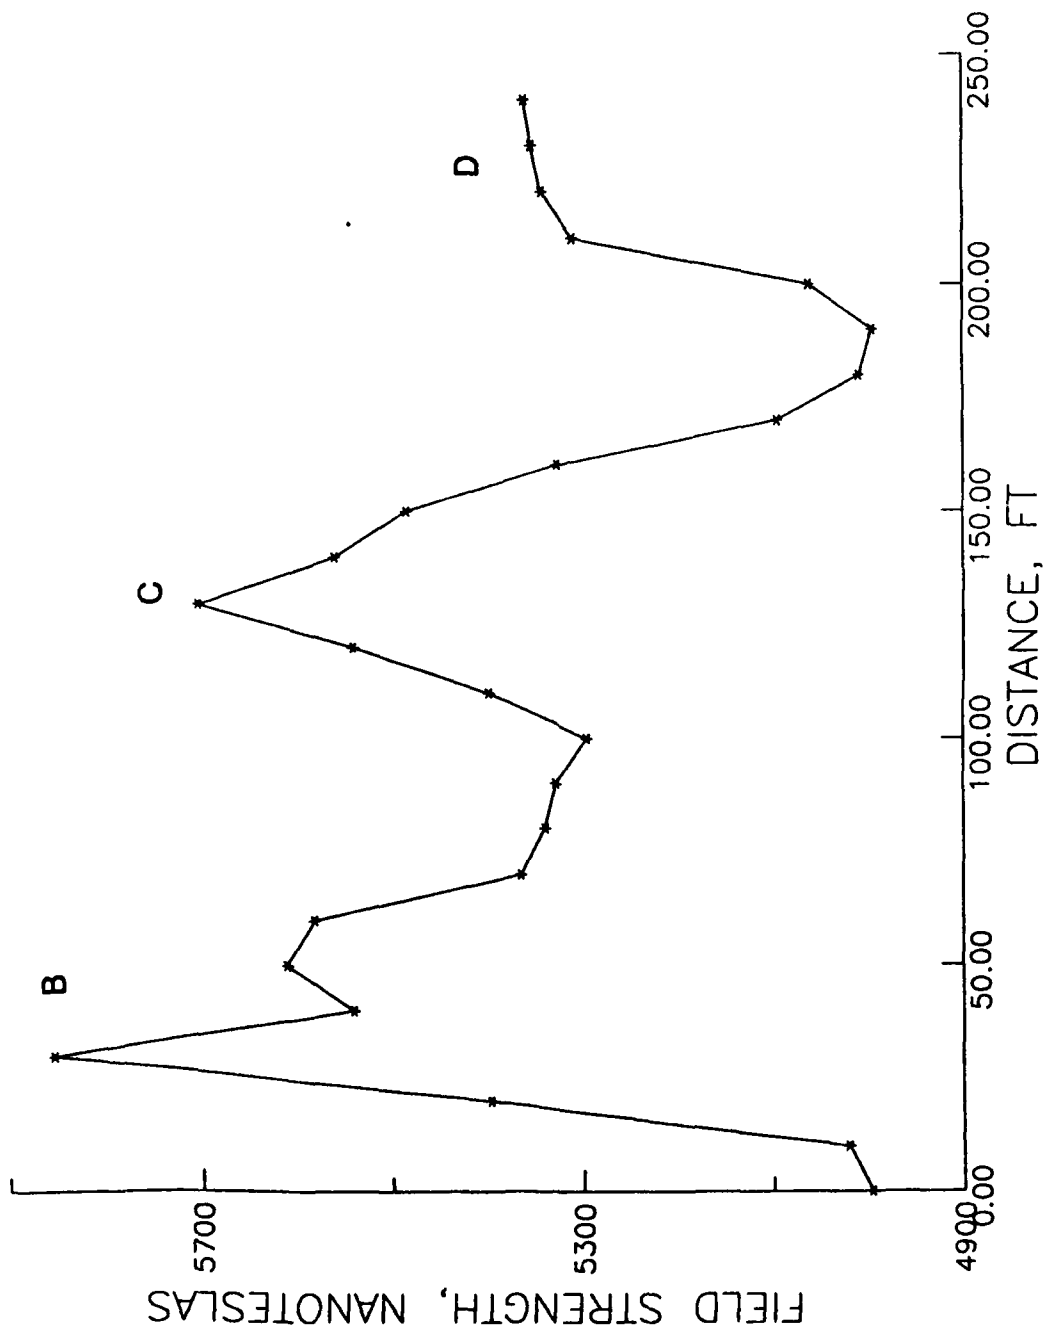
Figure 6. Magnetic survey data, line VI

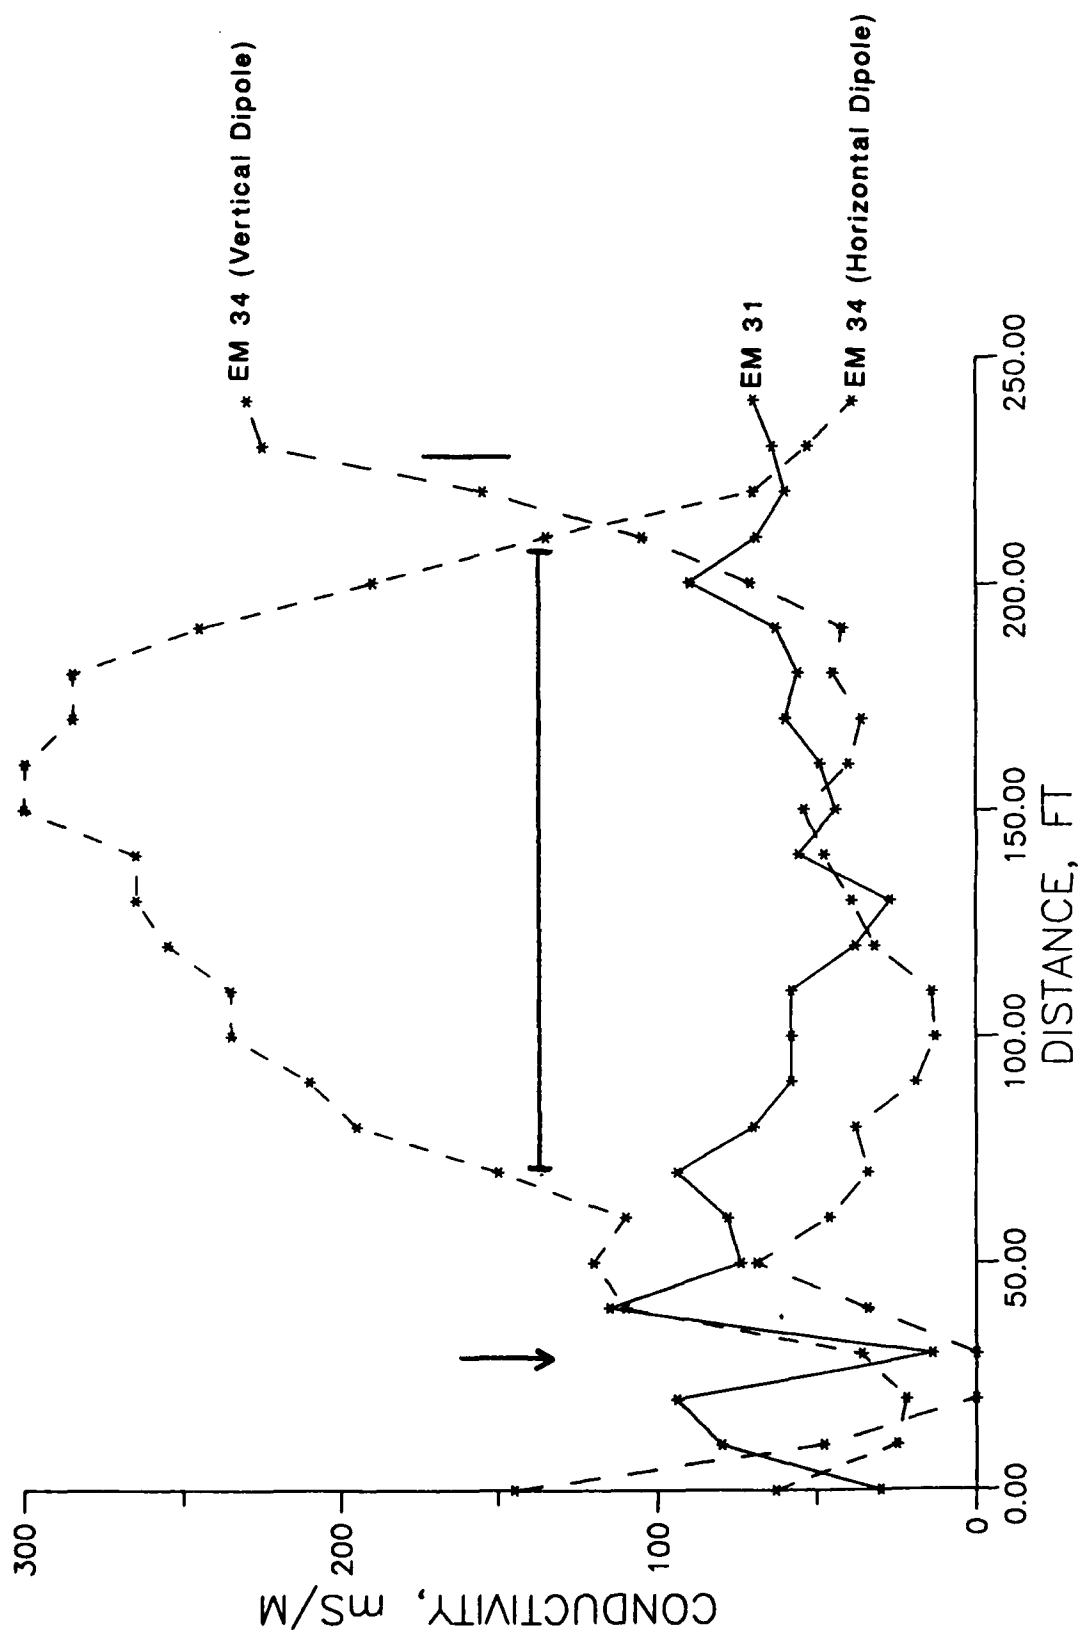
Figure 7. Electromagnetic survey data, line 1

10. The electromagnetic survey results, Figures 7-10, do not have the large, nearly periodic sequences of maxima and minima exhibited by the magnetic field data. Figures 7 and 8 show a large, broad response for the horizontal dipole EM 34 response (indicated by the horizontal bar in the figures); this response, which is not as evident (if at all) in Figures 9 and 10, is considered to be due to topographic effects on the data (sharp dropoff on one side and steep slope on the other side of the survey line). There is no evidence to support such a large conductivity value, since both the EM 31 and the vertical dipole EM 34 data consistently show much lower conductivity in this region of the survey line. All of the data in Figures 7 and 8 are consistent in exhibiting the anomaly indicated by the arrow; the anomaly has the classic appearance (maximum, minimum, maximum) produced by crossing a very conductive object, even tending to become negative directly over the object. The object causing this anomaly (at the arrow) is shallow (less than 18 ft, since it produces such a prominent effect on the EM 31 response) and must be large in size and possess a high conductivity (since the effect on the EM 34 is significant and the conductivity measurements tend to go negative). A high conductivity anomaly is present near the 240 ft profile position (indicated by the

vertical line) in Figures 7-10; in Figures 7 and 10, the anomaly is indicated by the vertical dipole EM 34 data but not obviously by the EM 31 data, while in Figures 8 and 9, the anomaly is indicated by both the EM 31 and the vertical dipole EM 34 data. Figure 12 indicates anomalous areas in plan from an analysis of the electromagnetic data.

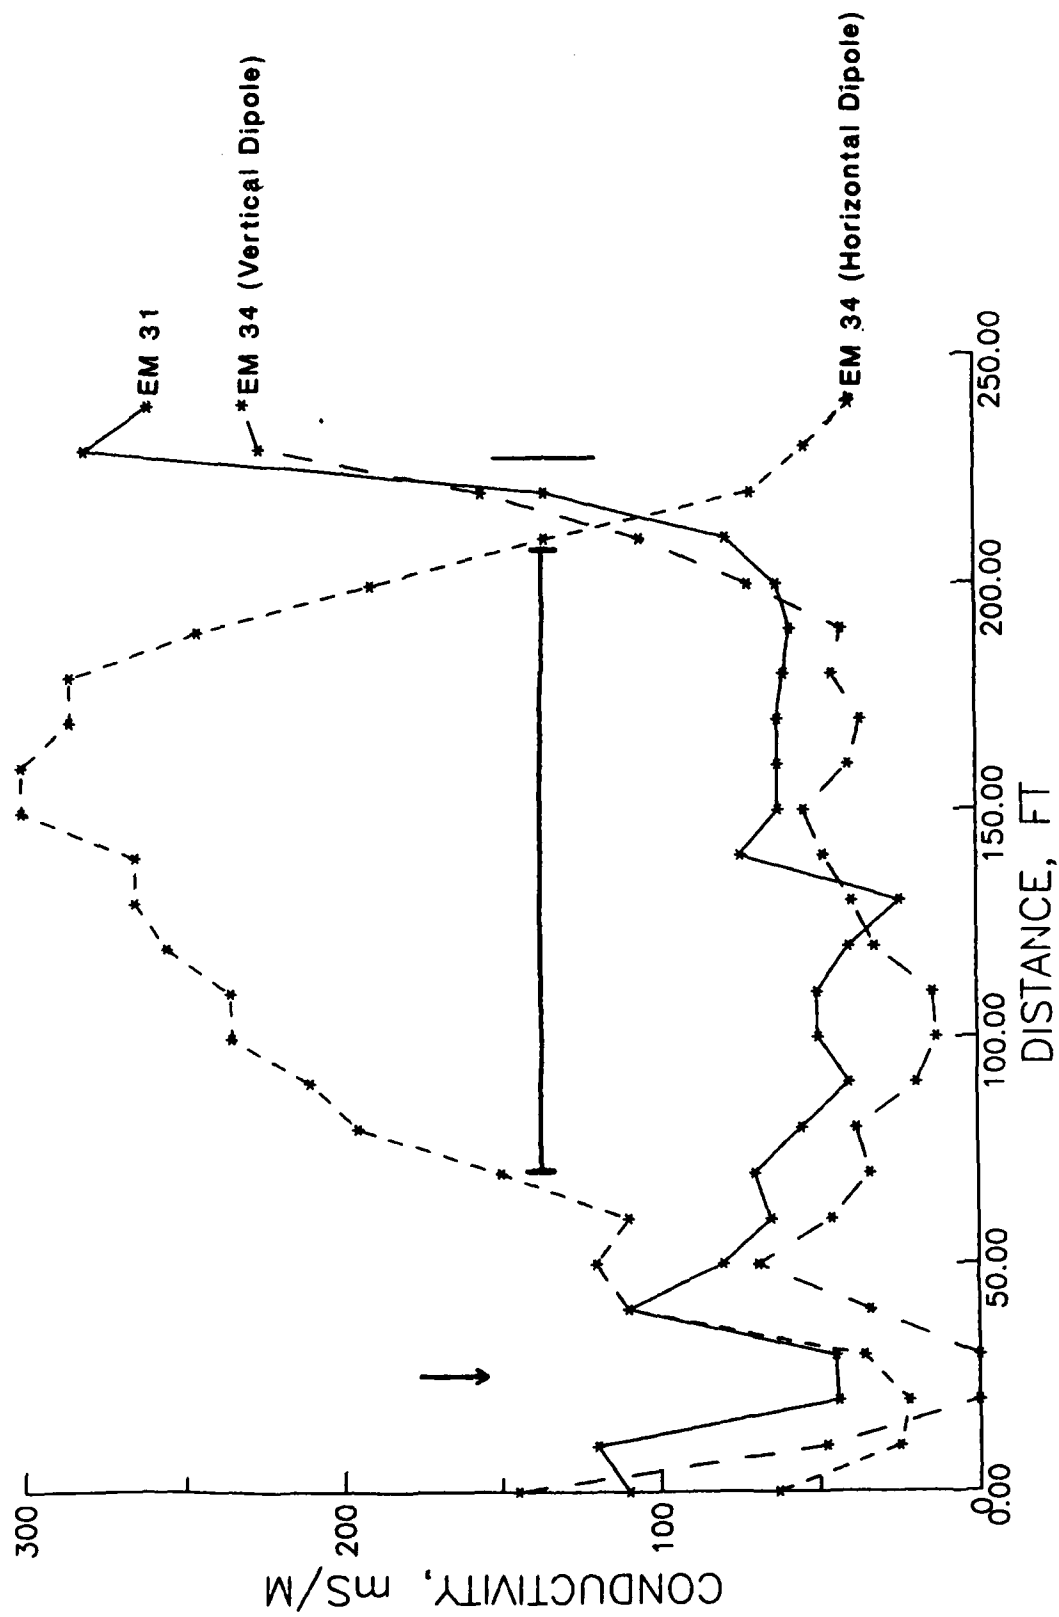
Figure 8. Electromagnetic survey data, line II

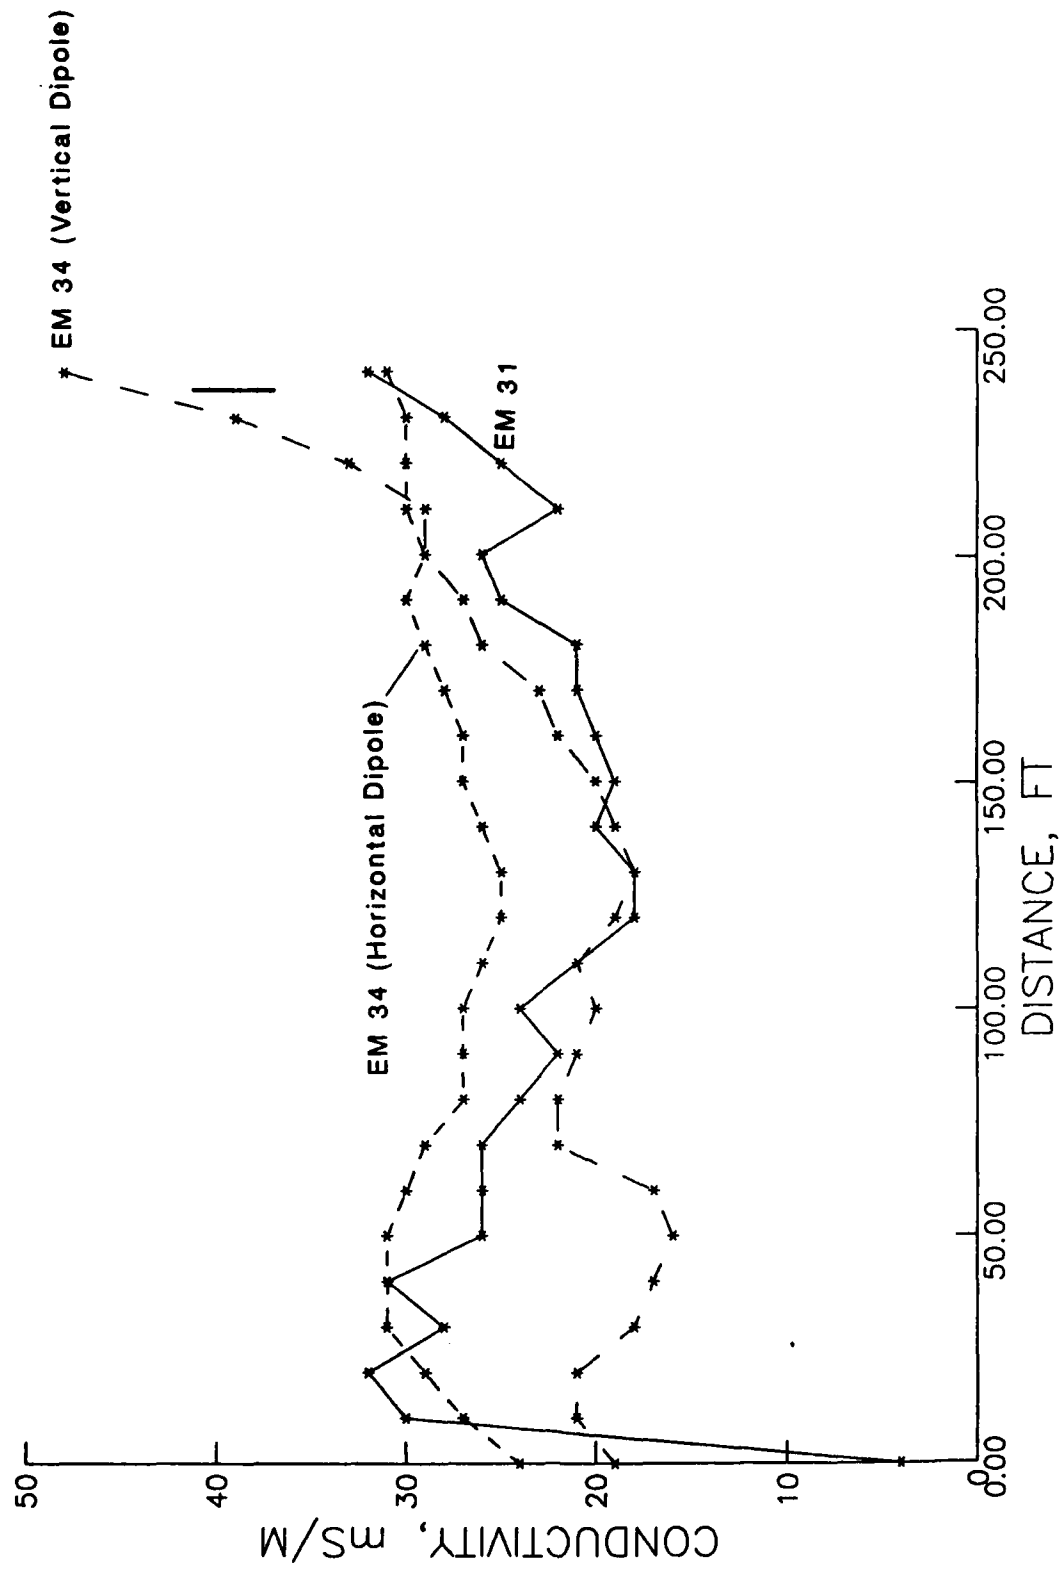
Figure 9. Electromagnetic survey data, line V

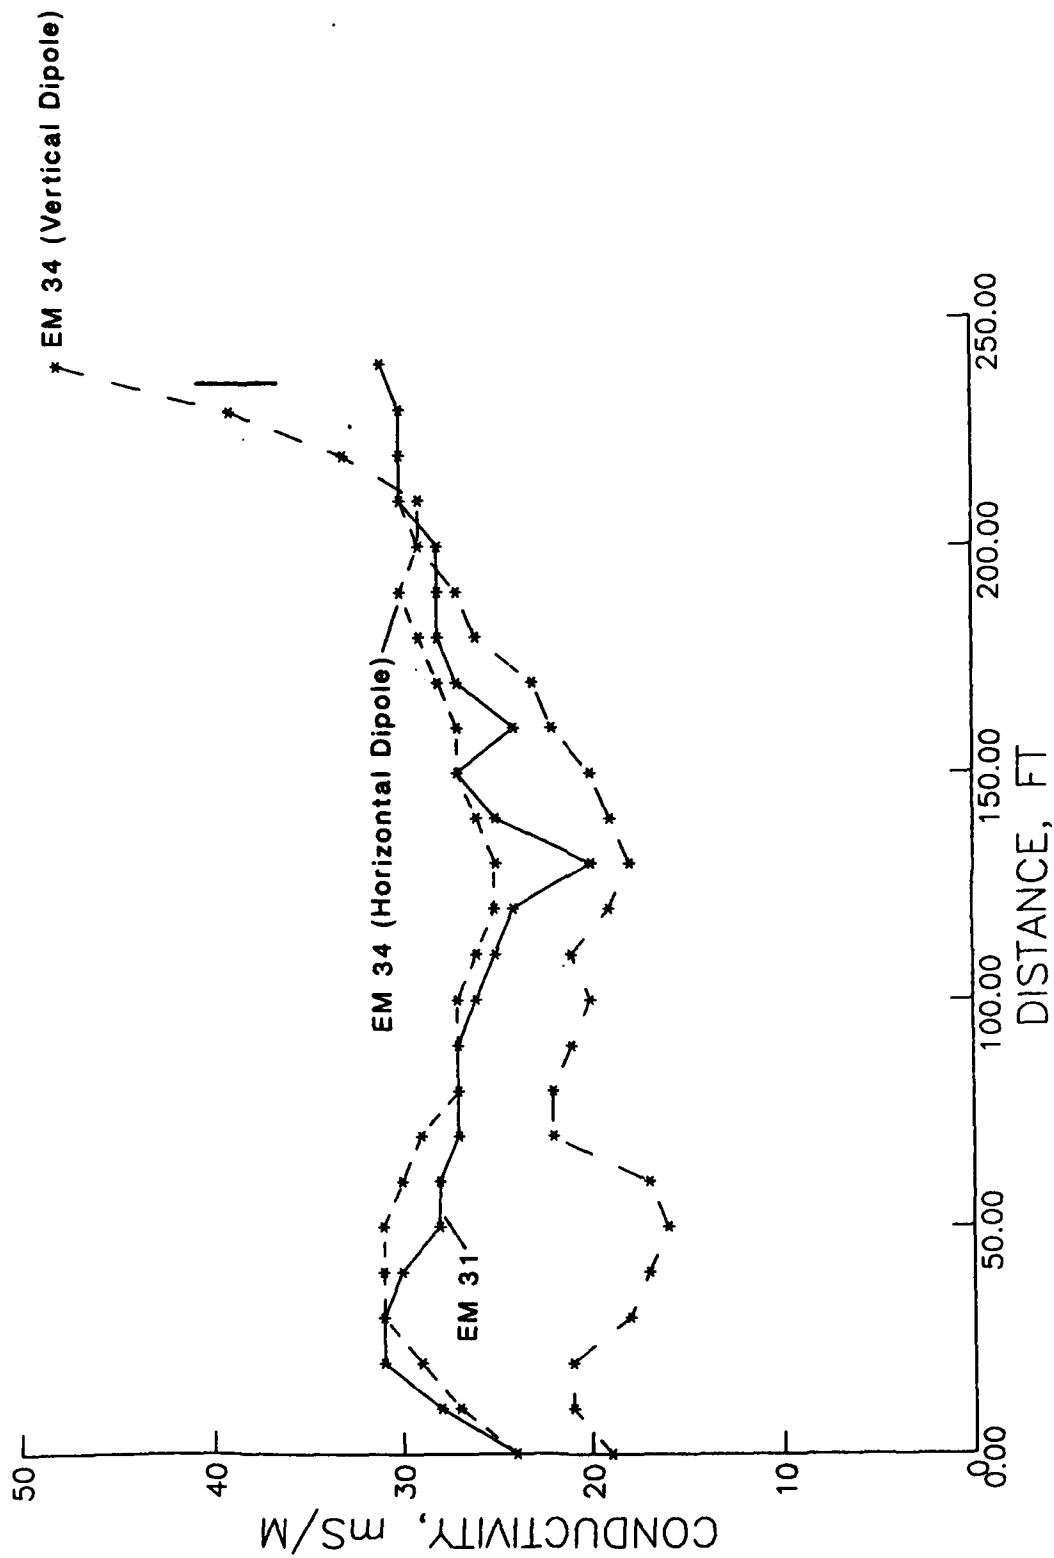
Figure 10. Electromagnetic survey data, line VI

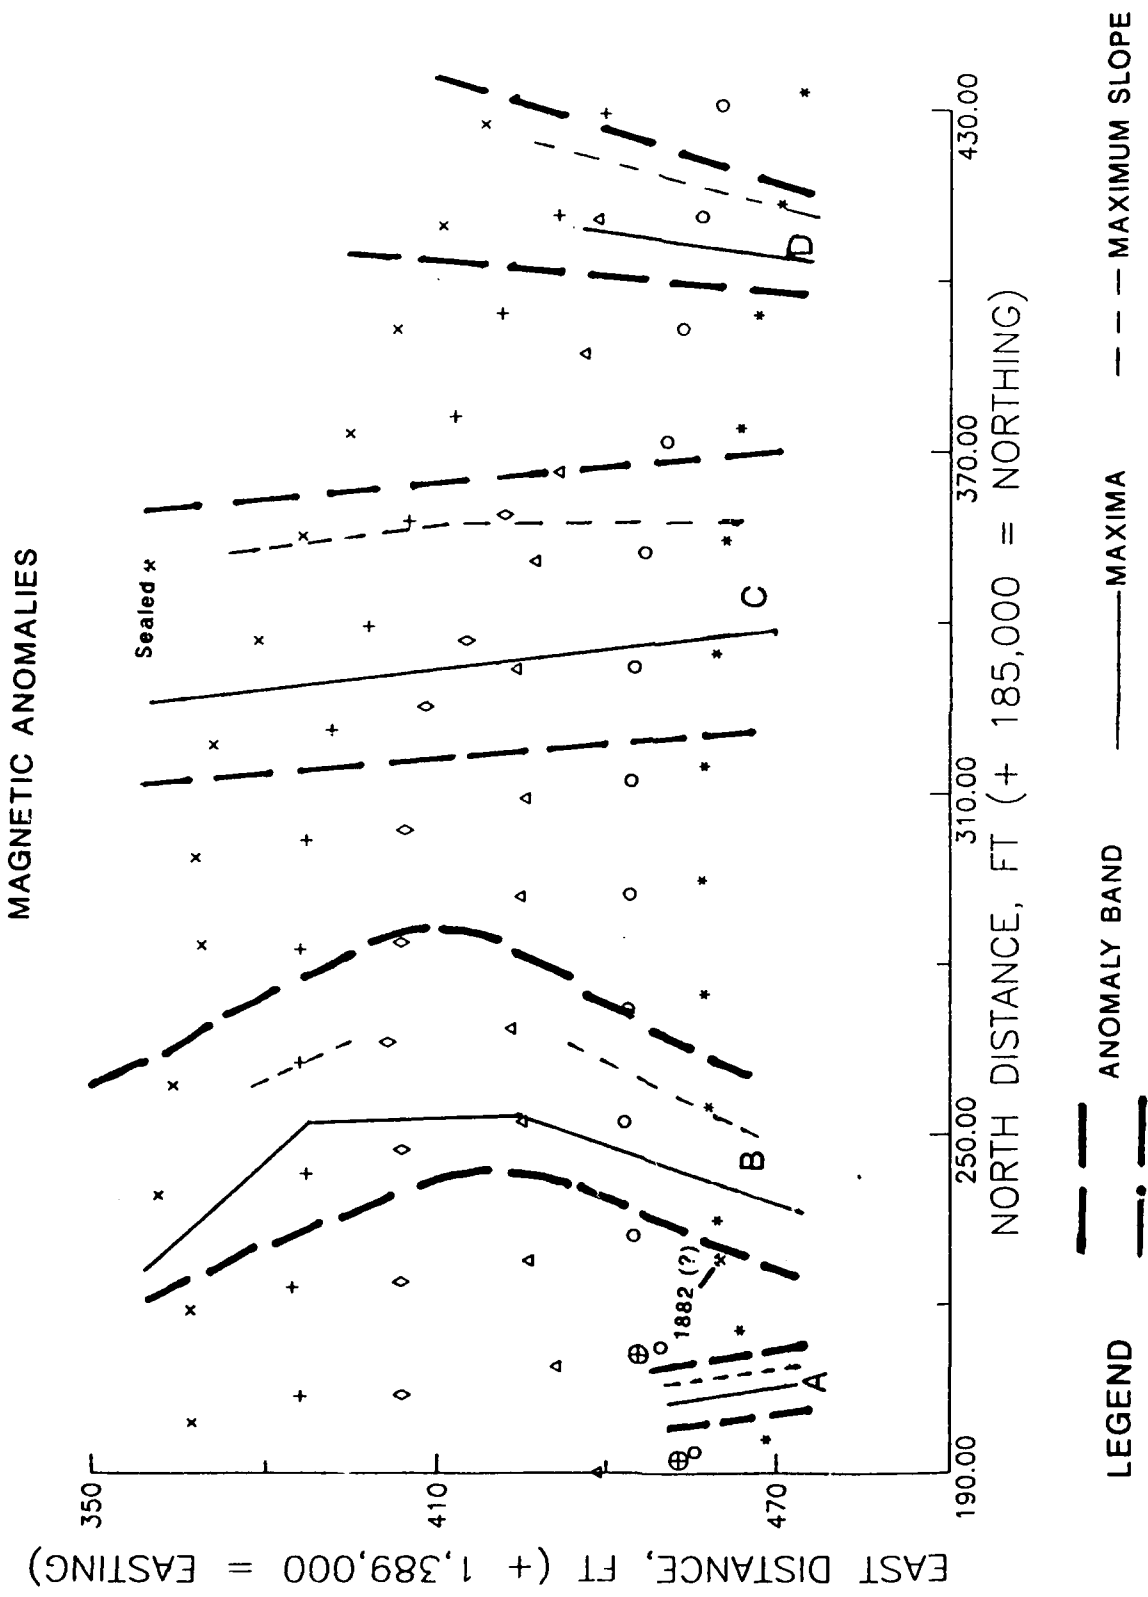
Figure 11. Magnetic anomaly map

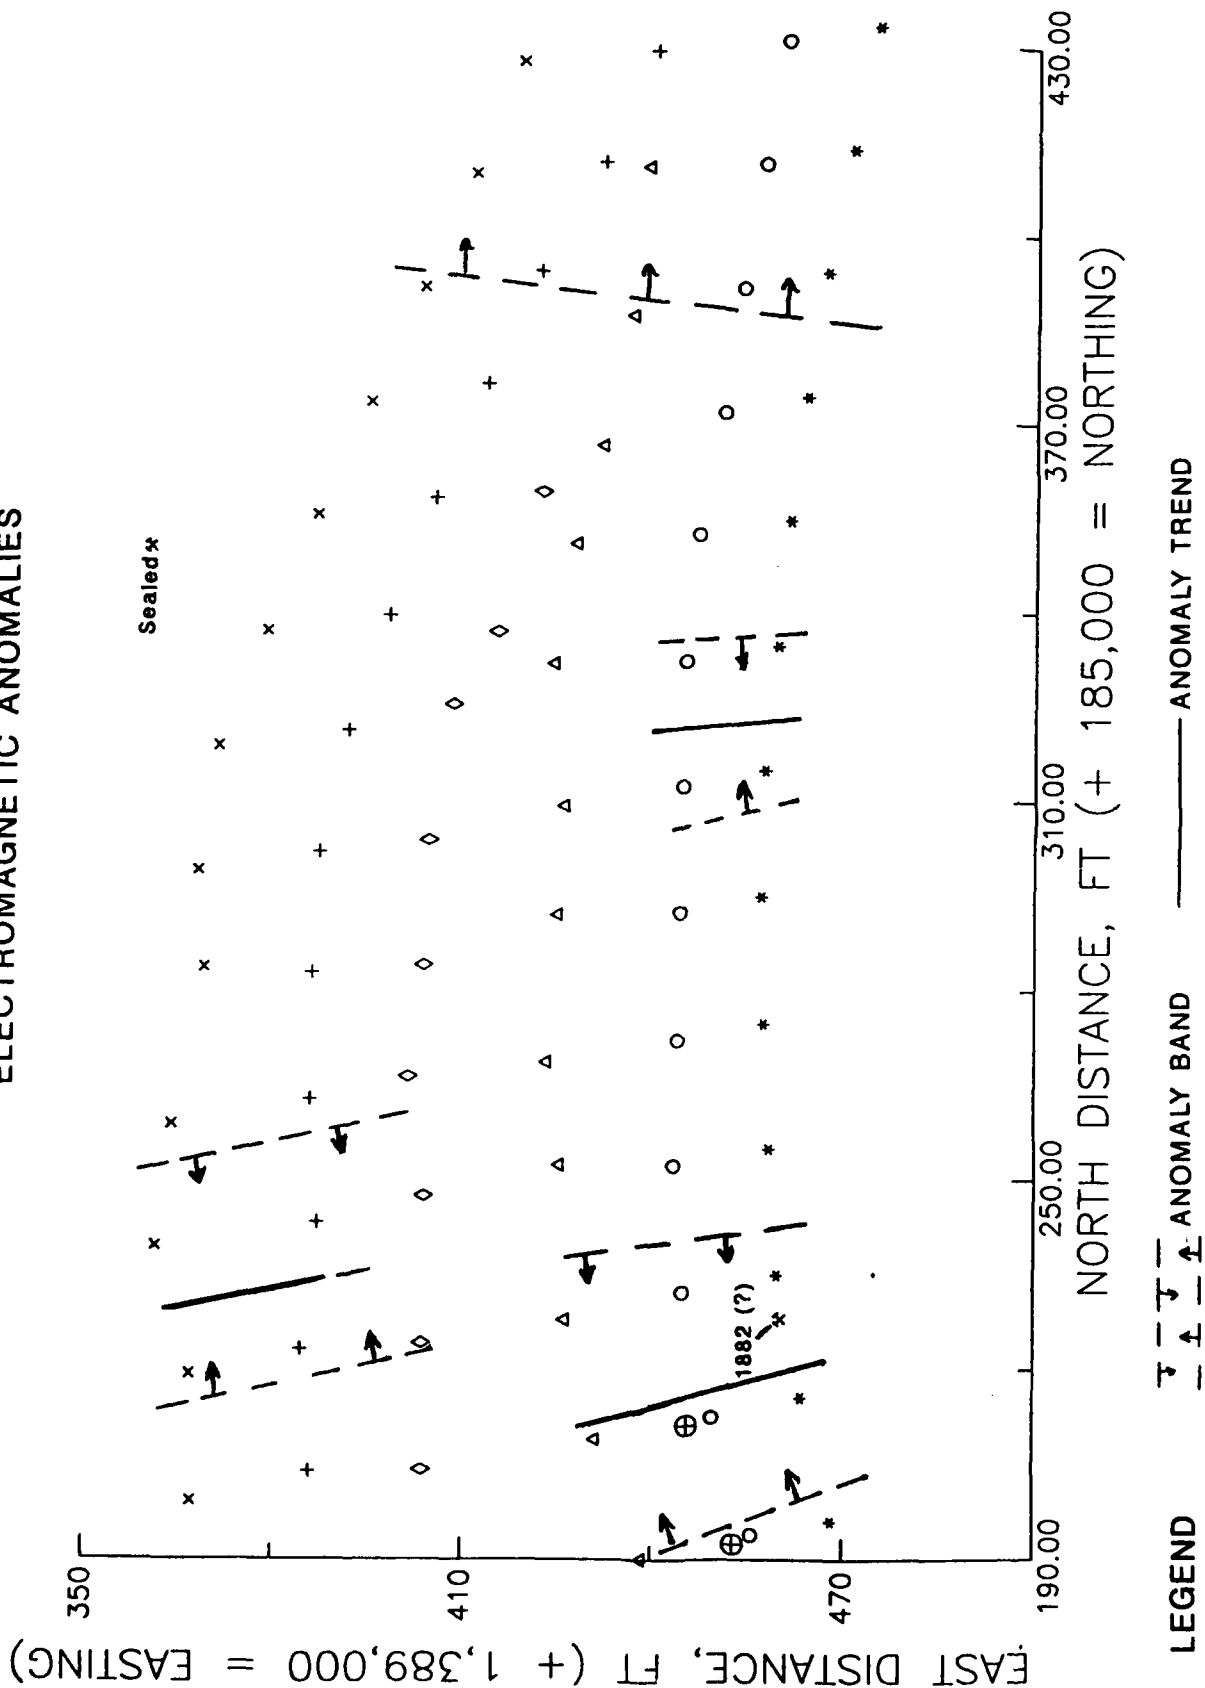
Figure 12. Electromagnetic anomaly map
